SUBJECT: Phase I Inspection Report  
Rainey Lake Dam  
Missouri No. 20267

RAINEY LAKE DAM  
JASPER COUNTY, MISSOURI  
MISSOURI INVENTORY NO. 20267

PHASE I INSPECTION REPORT  
NATIONAL DAM SAFETY PROGRAM

JULY, 1980

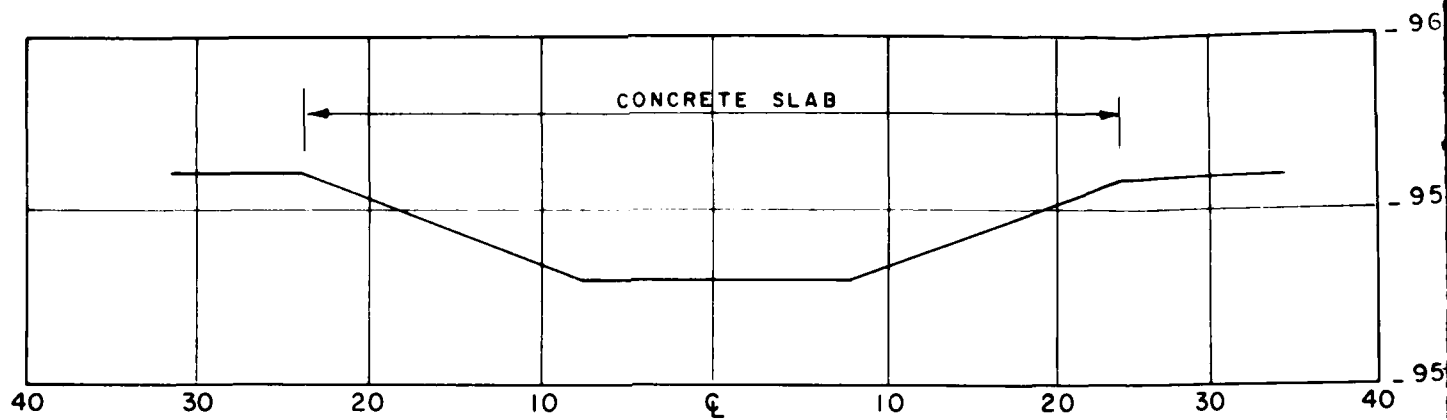
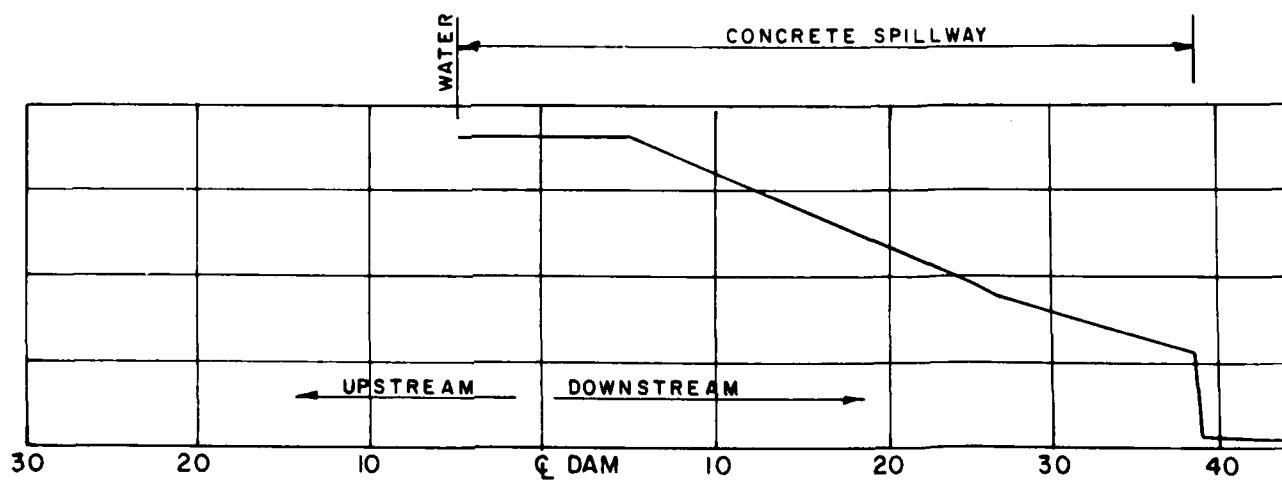
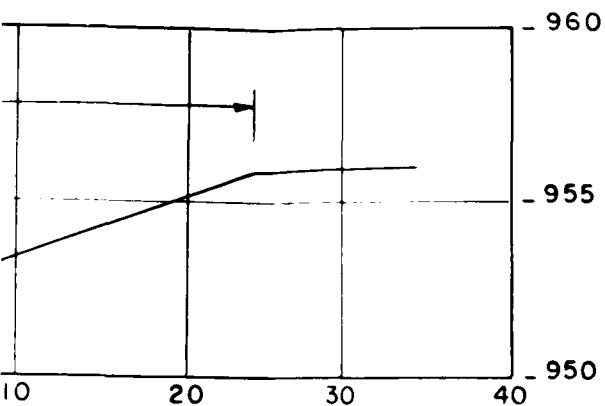
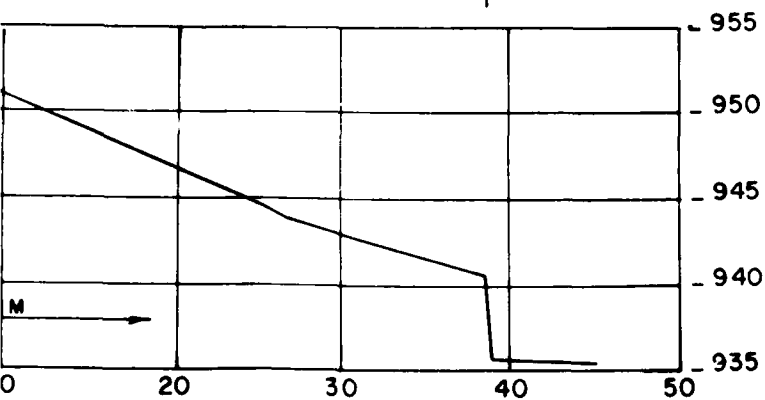
SPILLWAY  
SECTION & PROFILE

The principal spillway is a concrete lined trapezoidal section. Some minor cracking and spalling of the concrete was observed. Severe erosion under the slab near the outlet was noted. The erosion was starting to extend beyond the spillway along the toe of the embankment slope. The inlet and outlet to the channel were generally clear. Immediately downstream of the spillway, sections of 8 ft high steel swing gates were installed. The purpose of the gates was to allow the trash and debris to be carried under the gate as the gate swings up due to the flow. About 120 ft beyond the swing gates the channel is restricted by the three 9 x 12 ft box culvert cells constructed in the embankment of U. S. Highway 66.

- (3) The erosional areas on the embankment should be repaired and seeded.
- (4) The erosional areas beneath and near the concrete spillway should be repaired and maintained.

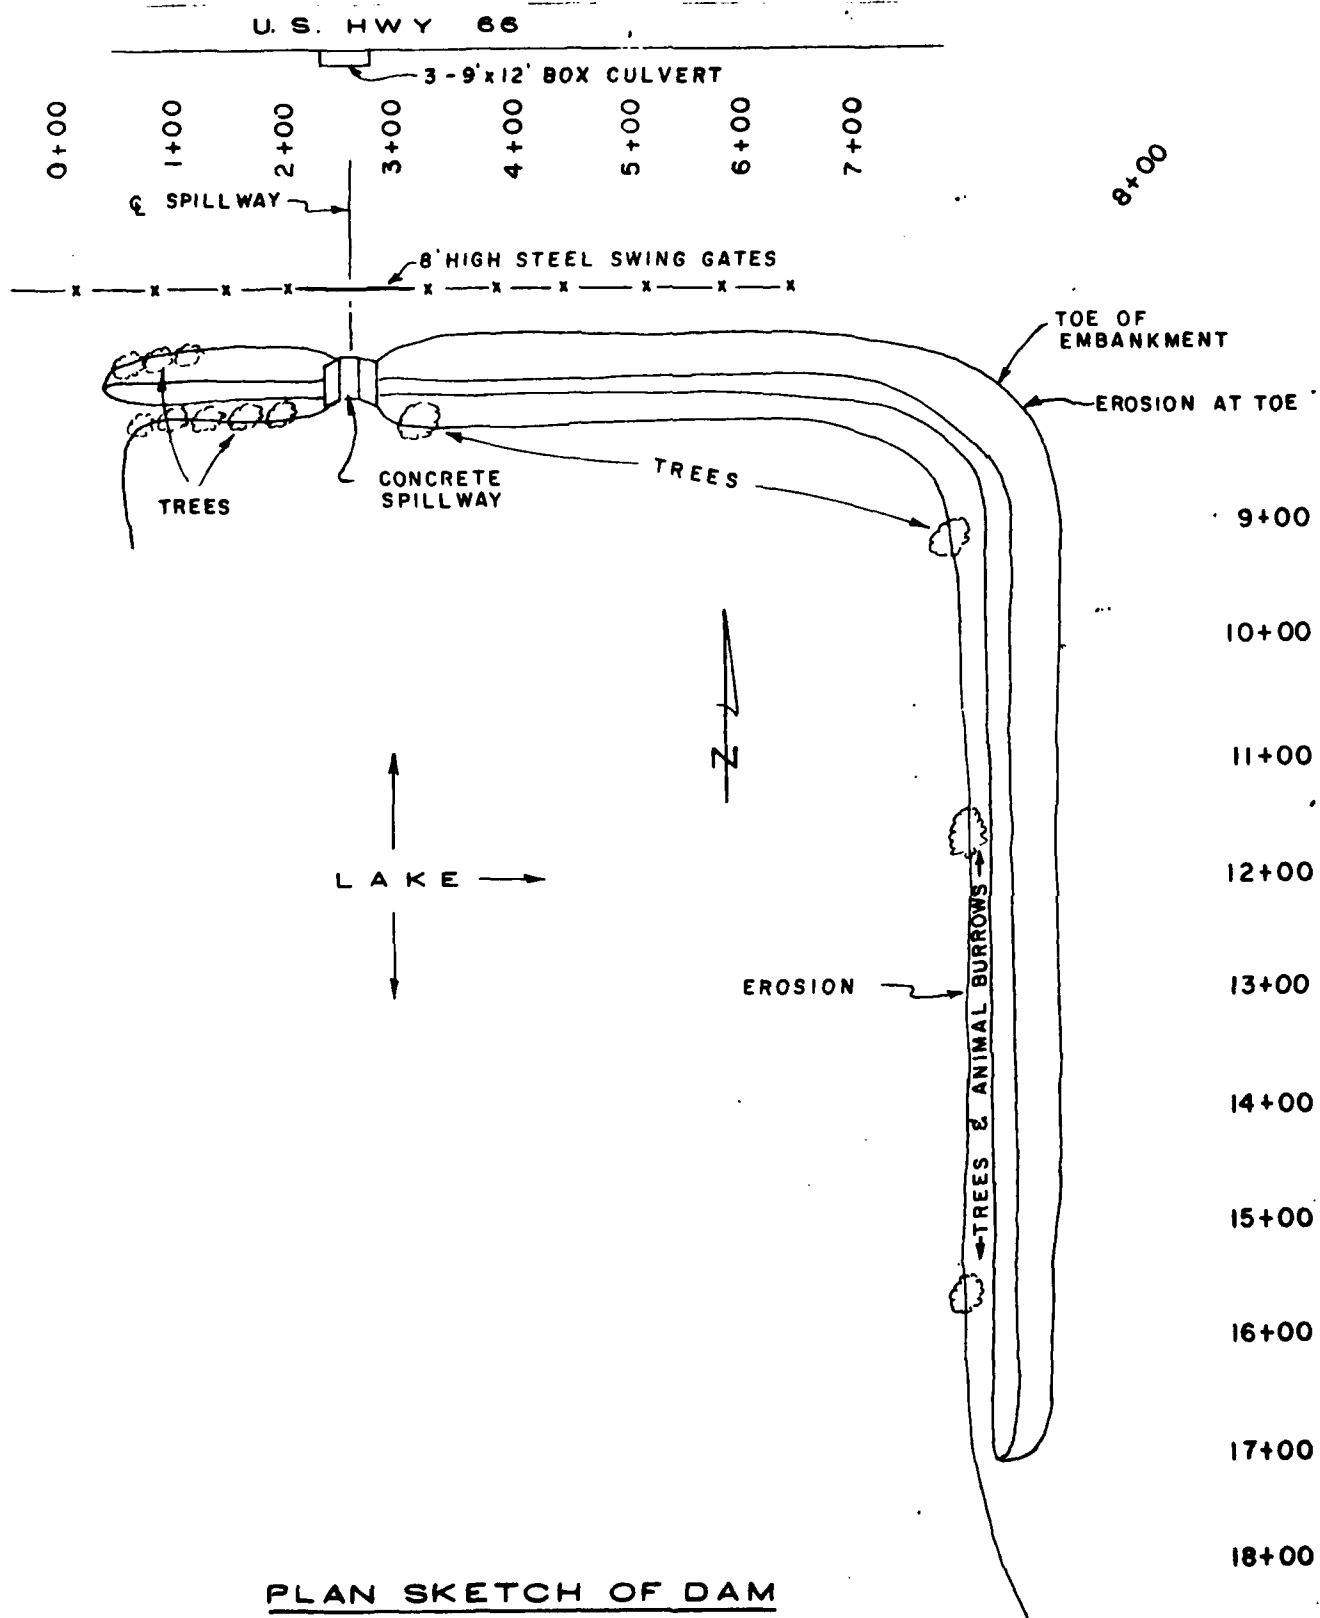
PLAN SKETCH OF DAM  
 RAINEY LAKE DAM  
 MO. No. 20267

Deficiencies visually observed by the inspection team were: (1) Erosional areas on the upstream embankment face at Station 13 + 00; (2) erosional area on the downstream toe at the curve of the embankment near Station 8 + 00; (3) numerous trees (4 to 24 in. diameter) on the embankment slopes; (4) animals burrows on the upstream slope between Station 9 + 00 and 13 + 00; and (5) erosion under the concrete spillway.
